DRAFT Technical Memorandum

Re: Draft Shoreline Habitat Inventory Memorandum

Anchor Environmental, L.L.C. and The Berger Partnership are assisting the City of Mercer Island in Master Planning activities for Luther Burbank Park in Mercer Island, Washington. In the past, shoreline conditions have been evaluated for the purpose of visioning park improvements (Reid Middleton 2002) and addressing shoreline erosion (Parametrix 1991). However, the park's shoreline has not been evaluated relative to its habitat value. Thus, Anchor performed this shoreline habitat inventory to characterize existing shoreline conditions for an array of fish and wildlife, including juvenile and adult salmon, bald eagles, birds, and amphibians. In addition, this inventory presents an overview of restoration and conservation opportunities for the park, considering the feasibility of implementing the actions that could be applied to increase the habitat value of the park's shoreline.

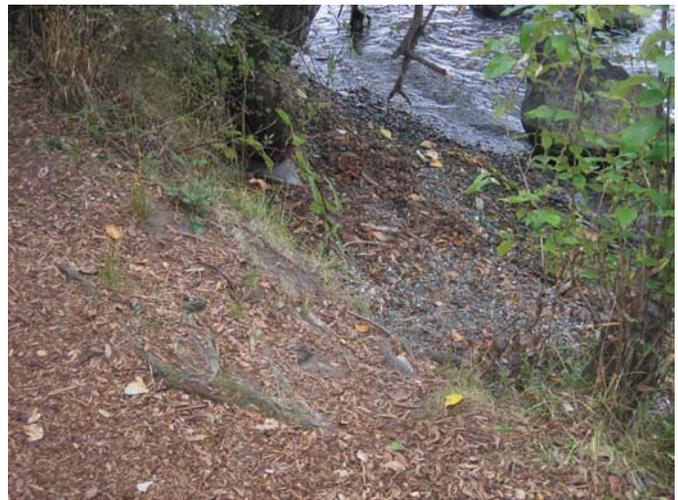
Additional notable shoreline conditions include several small erosion pockets with sand/gravel substrate that are being created as a result of severe shoreline erosion on the eastern park shoreline in the areas south of the dog off-leash area (Reach 11) , as well as in the reaches between the two docks (Reach 18; Photo 1). In some of these pocket erosion areas, the mulch from the walking trail is sloughing down the slope, onto the shoreline, and into the water. Shoreline structures include two dock complexes which extend approximately 235 feet and 130 feet waterward from the shoreline (Reach 16, Reach 19), and six visible outfalls which range from approximately 3 to 8 inches in diameter. These outfalls were dry during the site visit, except where submerged.

Photo 1. Erosion pockets; trail mulch extending into water.

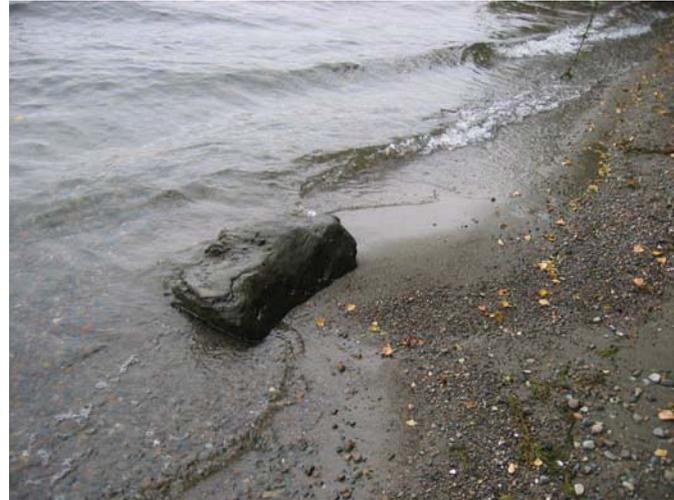
north/northwest ending at the 520 Bridge, to 1 to 1.5 miles to the southeast at the I-90 east channel bridge. Calkins Point is exposed to the longest fetch distances in either direction. During the course of this shoreline habitat inventory, it was noted that along the eastern shoreline south of the dog off-leash area, there were several scattered boulder piles with visible, but minor, sediment accumulations on the south side of the rocks (Reach 11; Photo 2); at this time, a strong southerly wind was blowing, and wave heights were approximately 0.5 feet.

Photo 2. Example of scattered boulders with minor sediment accumulation

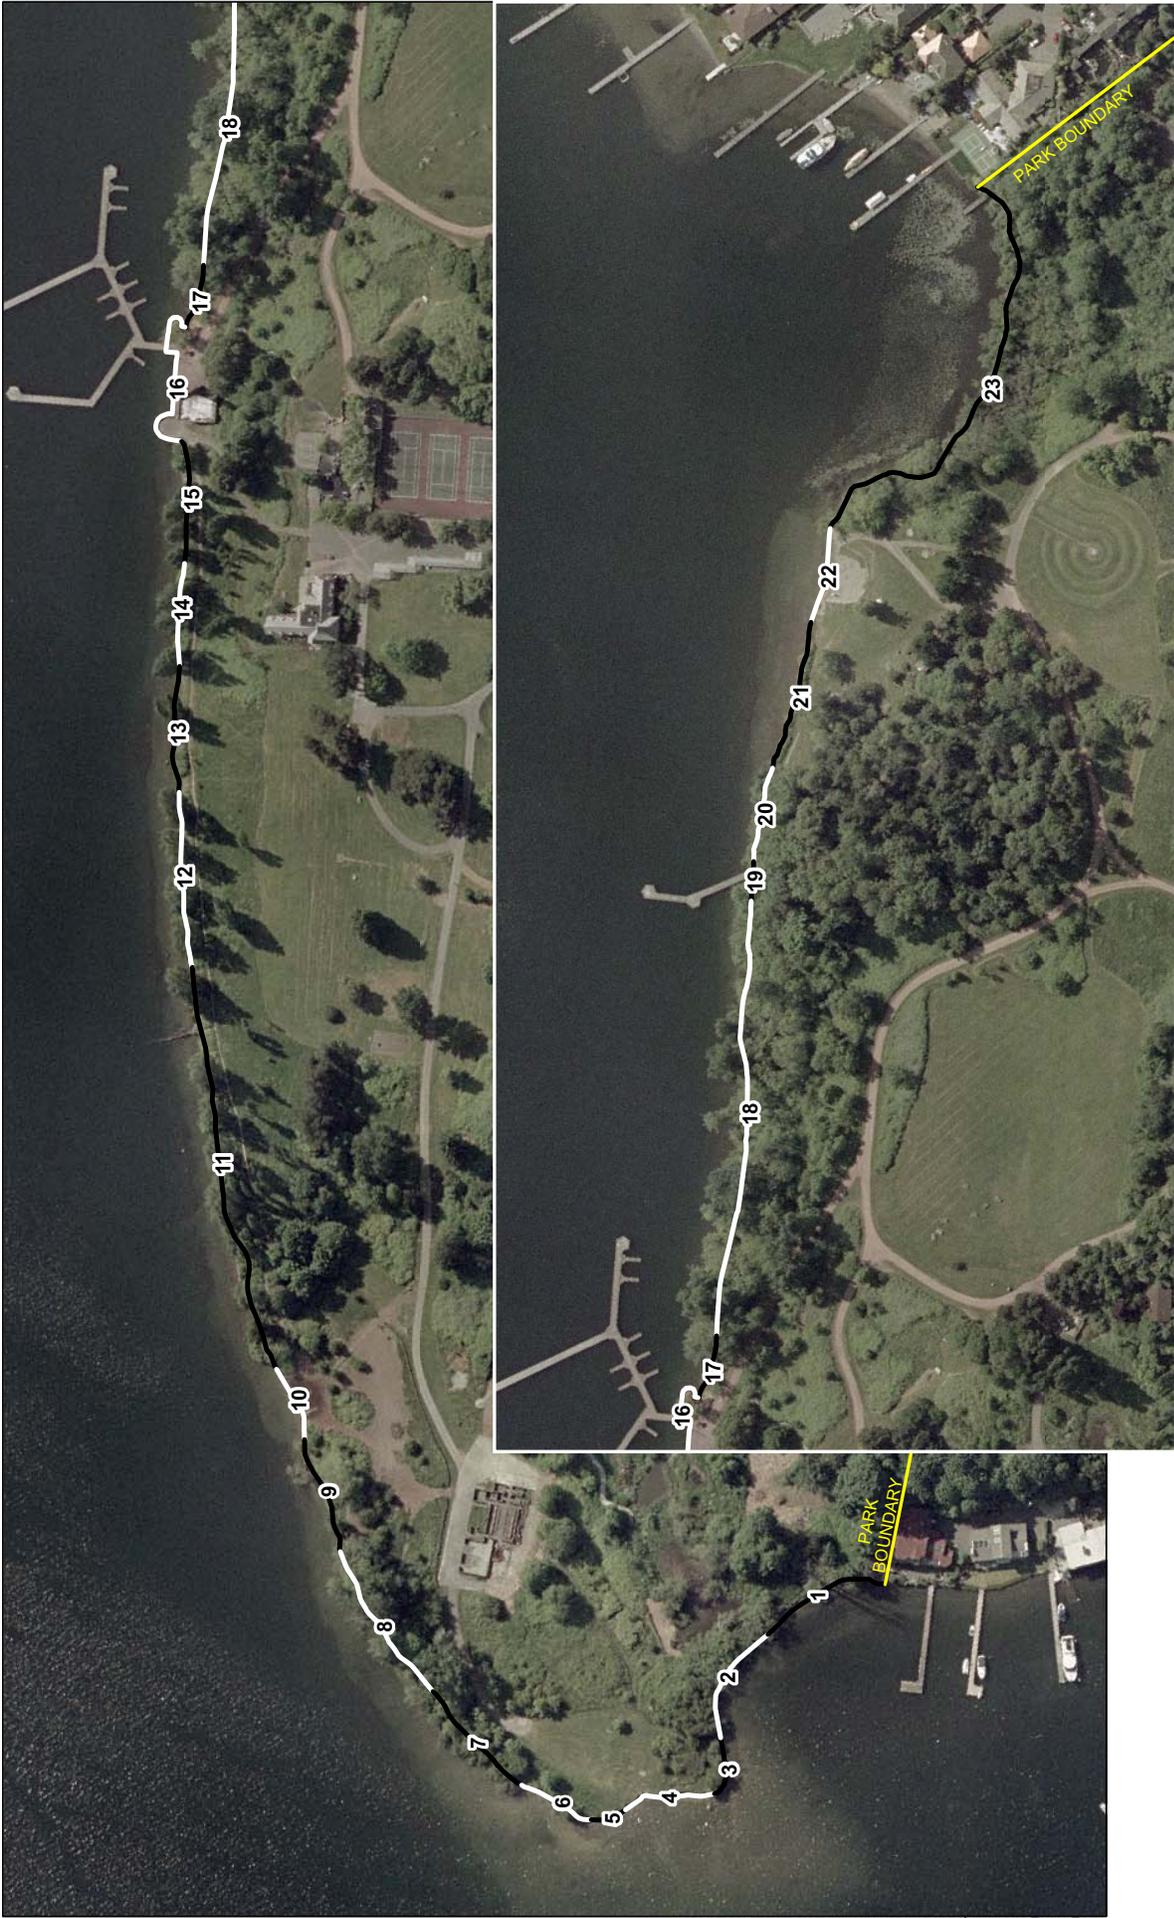
Figure 1
 Shoreline Habitat Reaches
 Luther Burbank Park Shoreline Habitat Inventory

To assess shoreline habitat conditions at the park, Anchor conducted a field site visit on September 29, 2005 to evaluate the park's approximately 4,280 lineal feet of shoreline (Figure 1). The shoreline of the park was divided into homogeneous shoreline segments ("reaches"), and conditions were identified based on key nearshore habitat parameters relevant to salmon and other species (Figure 1). Conditions were evaluated waterward between the ordinary low water (OLW) and ordinary high water (OHW) lines, and upland within 50 feet of the shoreline. Location data for the beginning and end of each reach were collected using a Differential Global Positioning System (DGPS). Data collected included physical habitat characteristics indicative of the natural shoreline habitat that would be present for fish and wildlife in this area (Table 1).
