**BUSINESS OF THE CITY COUNCIL  
CITY OF MERCER ISLAND, WA**

**AB 4326  
July 7, 2008  
Consent Calendar**

<b>COMMUNITY CENTER PARKING LOT REPAIR</b>	<b>Proposed Council Action:</b> Appropriate repair funds to address parking lot safety concerns.
--	---

# Drainage Issues at the Community Center at Mercer View

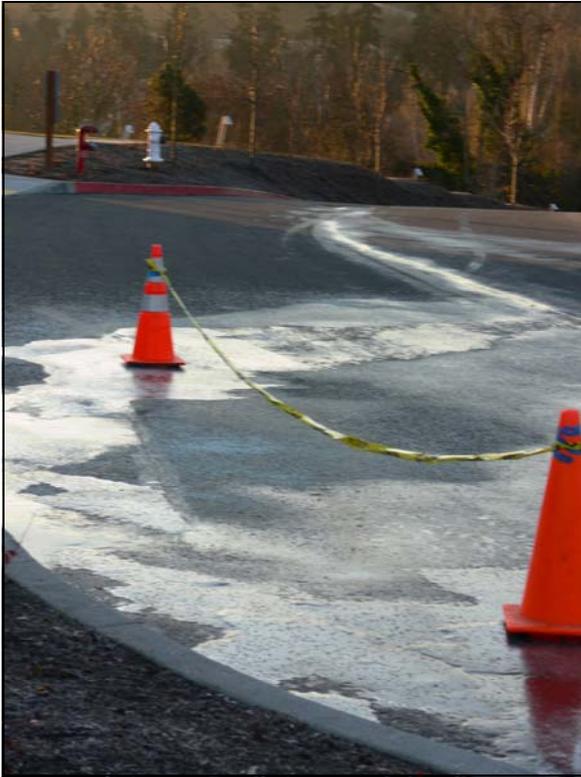
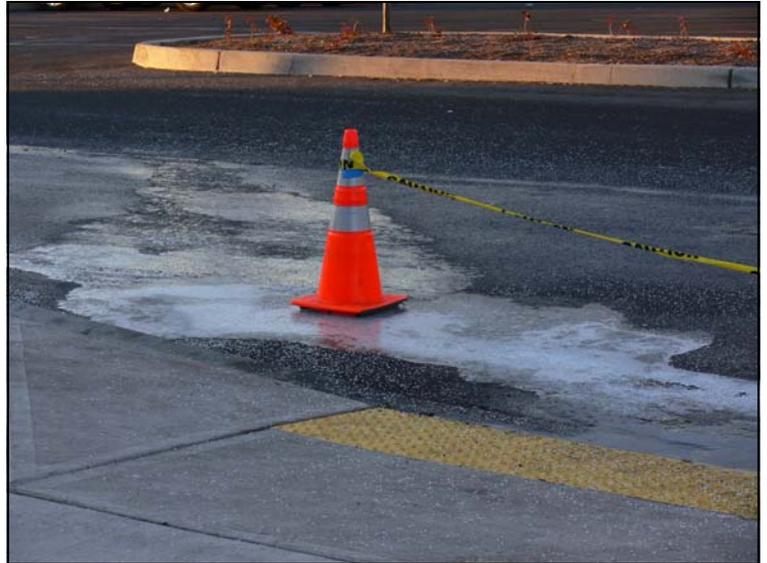
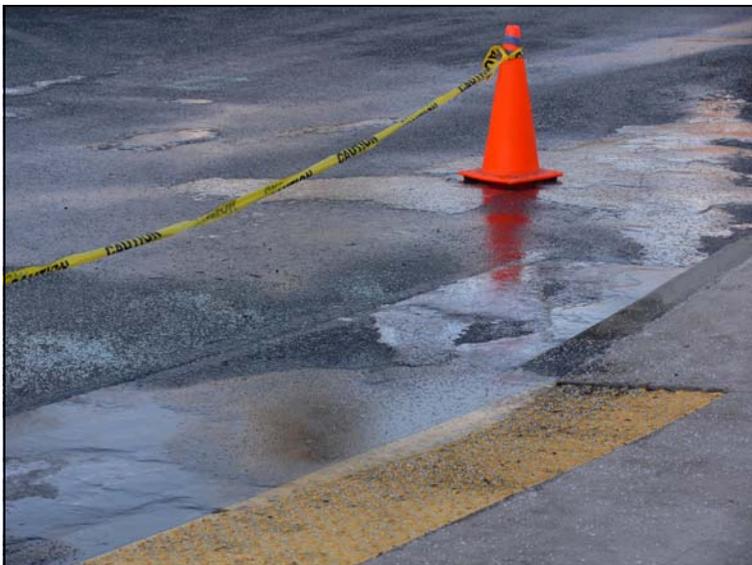
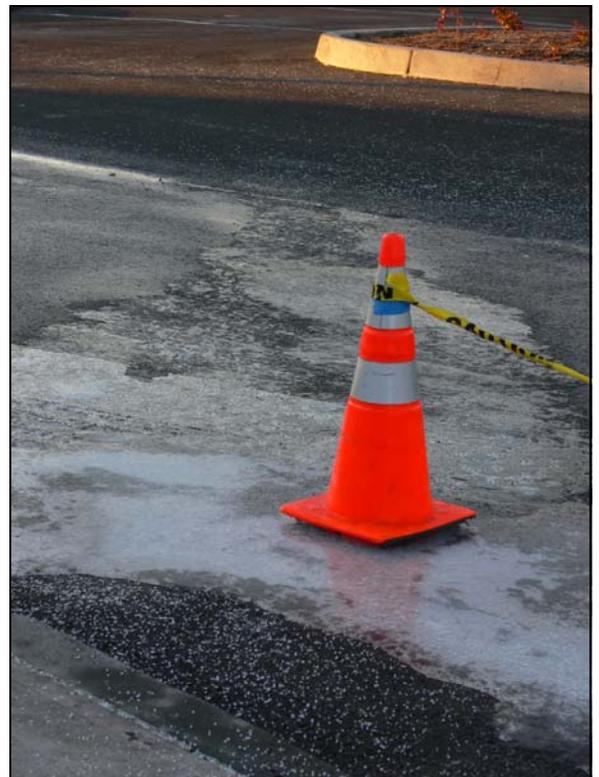
An item not identified during building and site inspections relates to parking lot drainage. Last winter, staff was made aware of a safety concern in the parking lot. During periods of rain, the upper parking lot does not drain properly, despite the proper location of catch basins. Existing contours direct water away from the catch basin installed to collect it and takes surface water from the upper parking lot area to the disabled parking stalls. The water pools up in this area as well as around the accessible sidewalk ramp and main parking lot entrance area where the majority of CCMV ingress/egress occurs.

Staff was not aware of the severity of this drainage issue until we experienced a stretch of extremely cold weather last winter. During cold and freezing weather, a sheet of ice forms from water flowing from the upper parking lot. Water travels down the hill, through the disabled parking stalls and pools where the ADA accessible ramp is located in front of the Center entrance. This ice creates a significant safety hazard for all of our facility users. In spite of diligent maintenance by staff attempting to keep this area sanded and de-iced, the parking lot remains a continued safety concern through the cold and stormy season (Exhibit 1).

Staff has sought and received bids to repair the drainage in this area. This proposed repair project will involve cutting-out a large section of asphalt, lowering the asphalt to channel the water towards an existing catch basin and re-patching the area with new asphalt. The estimated cost (including a 10% contingency) is \$43,570.
